**Strengthening of Strength Deficient
Corroded RCC Beams using
Carbon-fiber-reinforced-polymer and
Basalt-fiber-reinforced-polymer**

A thesis submitted in partial fulfillment for the
degree of Master of Science

Department of Civil Engineering

2024

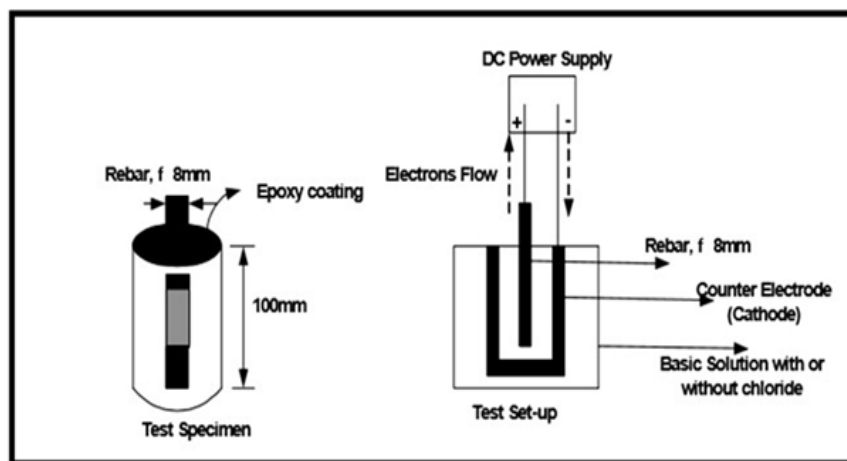
FIGURE 1.2: Battery assembly for Impressed current method (Sohail et.al, 2022)

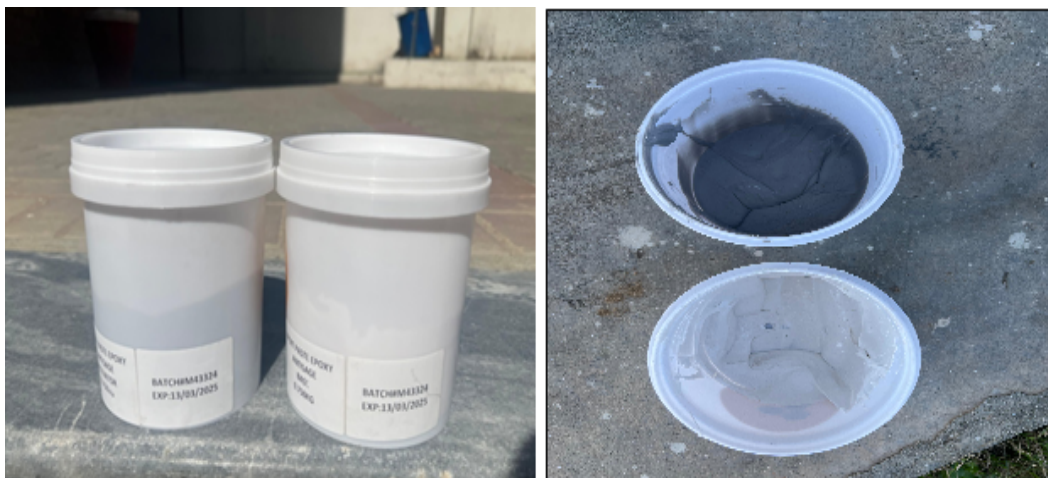
Base Paste Epoxy shown in Fig 3.6 is a trowel able, sag resistant patching compound for concrete and other substrates. This is applied to give CFRP/BFRP wraps a smooth surface. This compound is two components, 100% non-volatile filled epoxy/amine resin system. Part A and Part B is mixed with ratio 1:1 and its gives thick grey appearance when its wet and white once its dry. Compressive strength: ASTM D695 \geq 70 MPa @ 7 days , E-Modulus (compression): ASTM D695 \geq 12000 MPa @ 7 days , Tensile strength: ASTM D638 \geq 27 MPa @ 7 days , Adhesive strength: ASTM D4541 \geq 3.5 MPa (Concrete Failure), Pot life (F.I.P.) 50 - 70 min @25°C Mixing ratio 1:1 (Base: hardener) , Slant shear bond strength: AASHTO T-237-73 \geq 25 MPa (Old / New Concrete) ,Heat deflection: ASTM D648 \geq 50°C.

FIGURE 3.6: Base Paste Epoxy Part A and Part B, mixing ratio 1:1

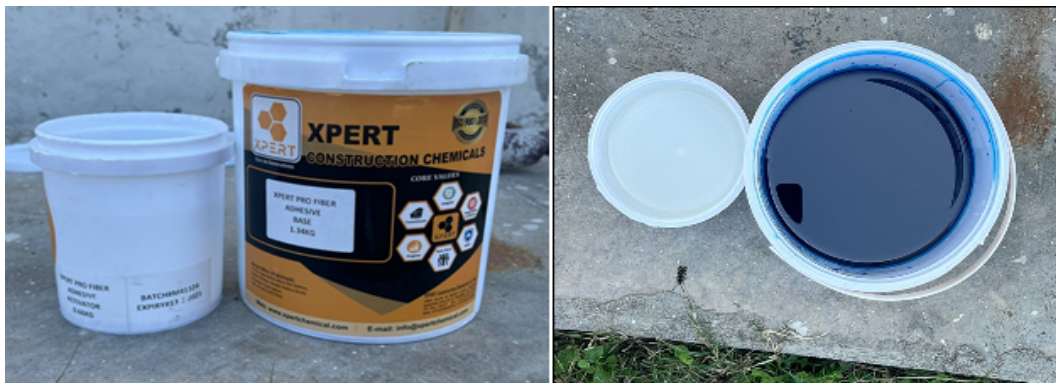
This adhesive also comes in two parts and mixed with ratio of 2:1 which gives dark blue glossy appearance Fig 3.7. Adhesives are used to stick CFRP/BFRP wraps with base epoxy which is applied at soffit of beam or concrete substrate surface by rollers at the rate of 0.25 - 0.30 kg/m² . XPERT PROFIBER CW ADHESIVE is 100% solids, low viscosity epoxy material that is used to encapsulate Profiber carbon, basalt, glass, and aramid fibre fabrics. Adhesive cures to provide a high performance FRP laminate. The resulting FRP laminate can provide additional strength to concrete, masonry, steel, and wood structural elements. It is Used to encapsulate any fabric and acts as a substrate primer for the wet application it is 100% solids epoxy Low odor, low VOC's .its Yield Strength is (55 MPa) Strain at Yield 2.5%. Elastic Modulus (3034 MPa), Ultimate Strength (55.2 MPa) and Rupture Strain 3.5%. While at flexural its Yield Strength Is (138 MPa), Elastic Modulus (3724 MPa) and Ultimate Strength (138 MPa). Crack filler with Low

FIGURE 3.7: Adhesive in two parts and mixed with ratio of 2:1

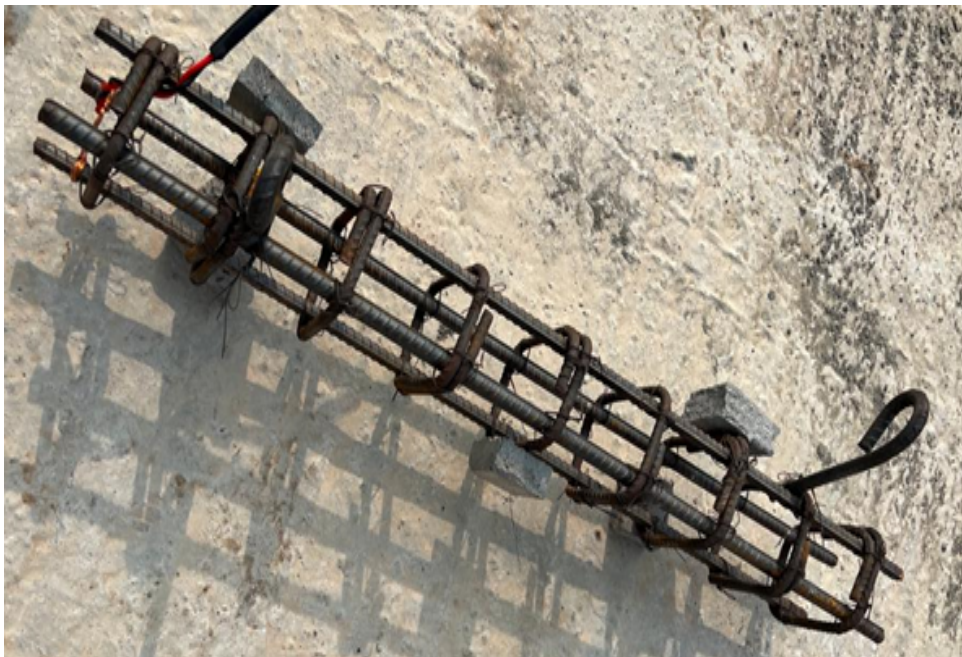
Steel used is 60 grade having good quality and tensile strength. #3 and #4 bars were used and cut into lengths desired. 4 flexural bars each having length 900mm and 9 stirrups each has length 600mm longitudinally and laterally steel skeleton is shown in Fig 3.8. Binding wires were used to tie up flexural bars and stirrups. And one loop handle of #4 were attached with steel skeleton to make handling easy once beam cures and transported. PCC spacers of thickness 37mm were used at sides of reinforcement as concrete covers Fig 3.9.

FIGURE 3.9: Beam steel skeleton longitudinal face

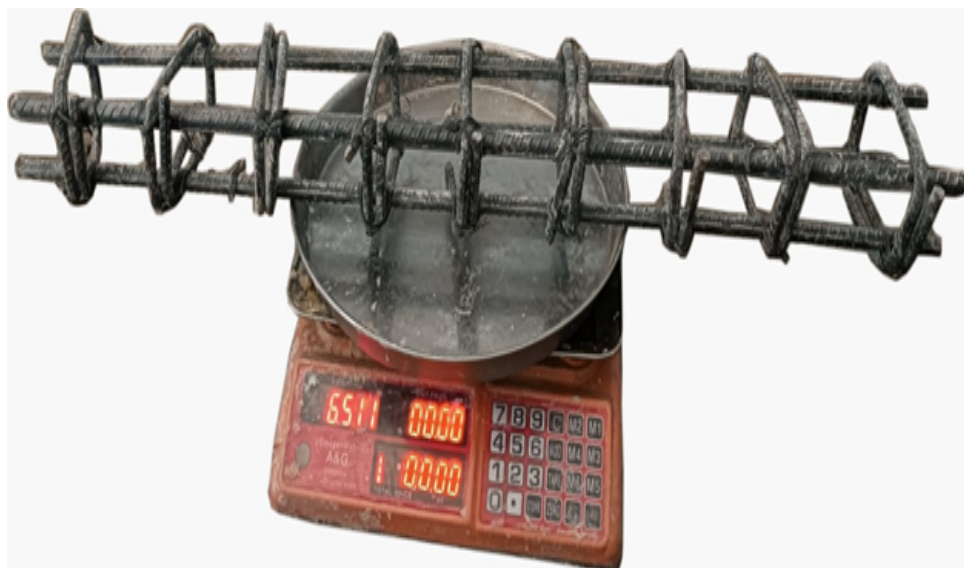
FIGURE 3.17: Total weight of beam steel skeleton before corrosion

In our case we expected 10% theoretical weight loss of the steel bars. Total weight of the beam was 6511 g Fig 3.16 , so the $\delta m = 651$ g. Time decided to apply current was 8 hours per day for consecutive 15 days. So $t = 432000$ s. Regardless of

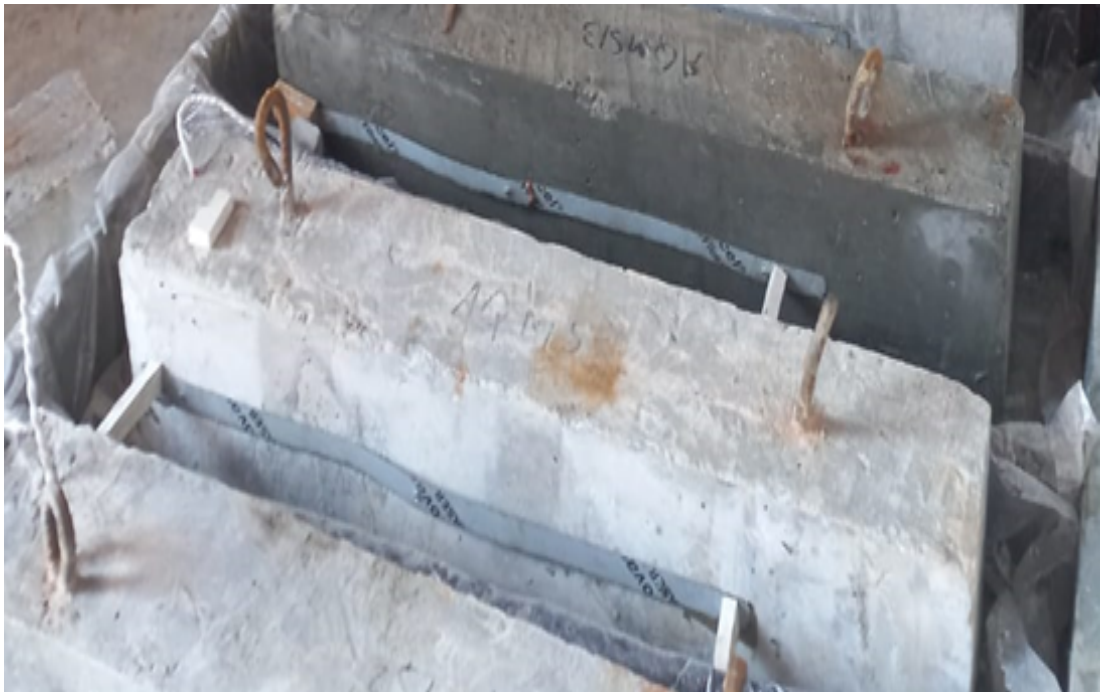
FIGURE 3.19: Stainless Steel cathode attached with beam

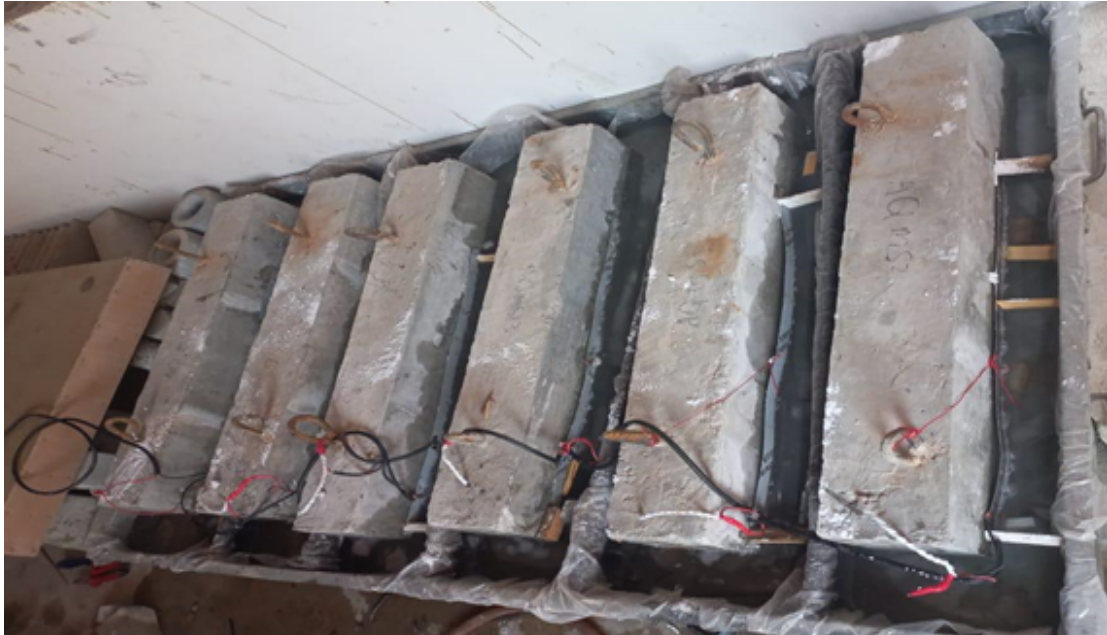
FIGURE 3.21: Physical interpretation of Schematic circuit of beams connected in series

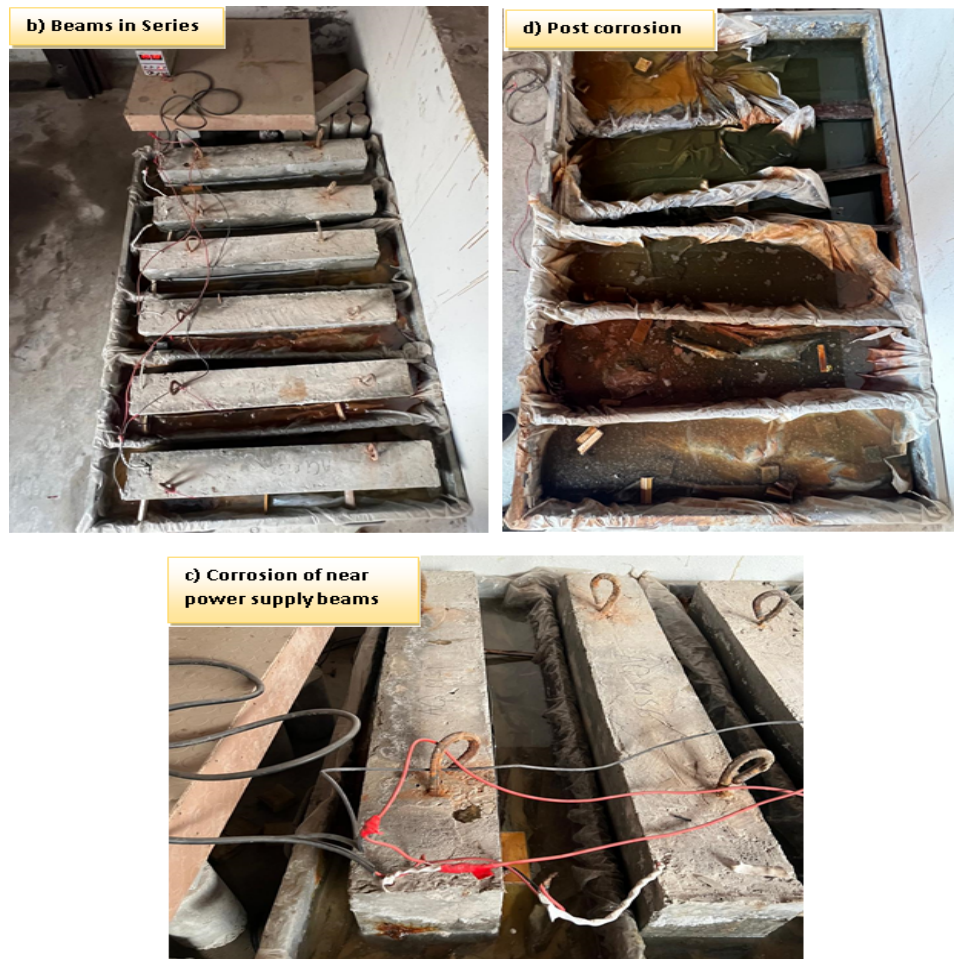
Interval base current was applied for 15 days at 8hr/day. With the passage of time we can see clearly corrosion firstly appears externally due to NaCl present in water and environmental effect. Then slowly it goes into the flexural bars of the beam which are embedded in the beam and visually not present. We can see bottom of the beams got reddish in color and some portion of the cathode also deteriorated. That shows current is flowing even the end beam has turned its bottom side appearance into rusty color. Ammeter is also used to check whether current is flowing or not. Current was kept 5.01 A constant, through manual regulators attached at the face of power supply. The real-time, continuous deterioration process in the beams installed in the steel tank is shown in Fig. 3.21(a), (b), and (c). The corrosion behavior of the reinforcement mesh is said to be unaffected by the number of connected flexure rebar [35].

FIGURE 3.22: Beams under corrosion stage

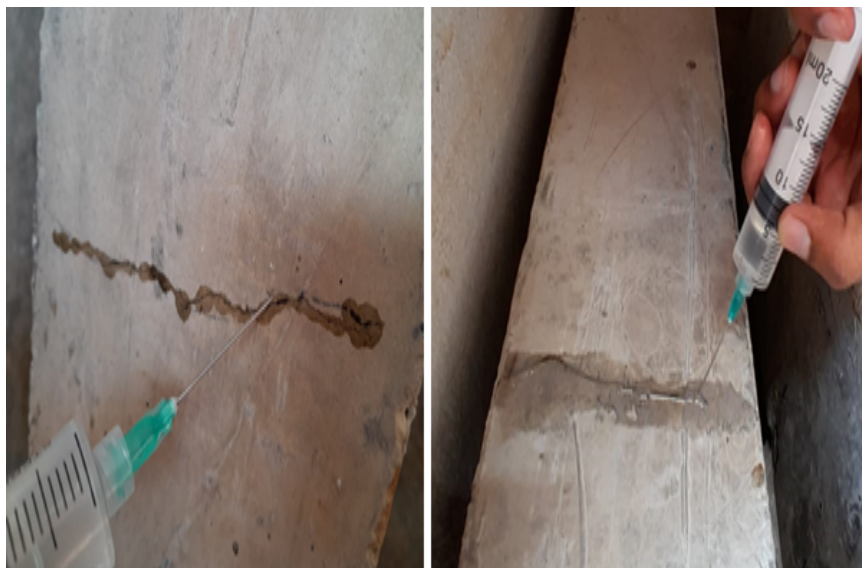
All the strengthening procedure for these is same as above except one step must be ensured before strengthening of these beams. Low Viscosity two Component resin is filled in cracks & pin holes with Injection Fig 3.31. This is done so that beams which are loaded up to 70% of ultimate load shows cracks when de-loaded from lab apparatus. If we fill these cracks with this resin it might help to increase its strength also. Further follows the same procedure for both CFRP and BFRP wraps. 2x preloaded beams are strengthened with CFRP & two with BFRP.

FIGURE 3.32: Cracks filling with filler resin using injection

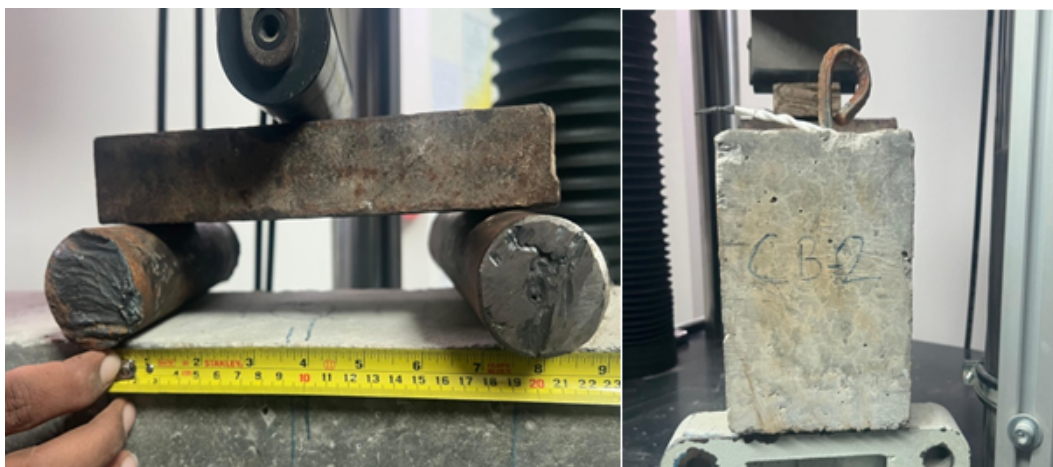
FIGURE 3.34: Rods & Wrought iron plate for four point loading

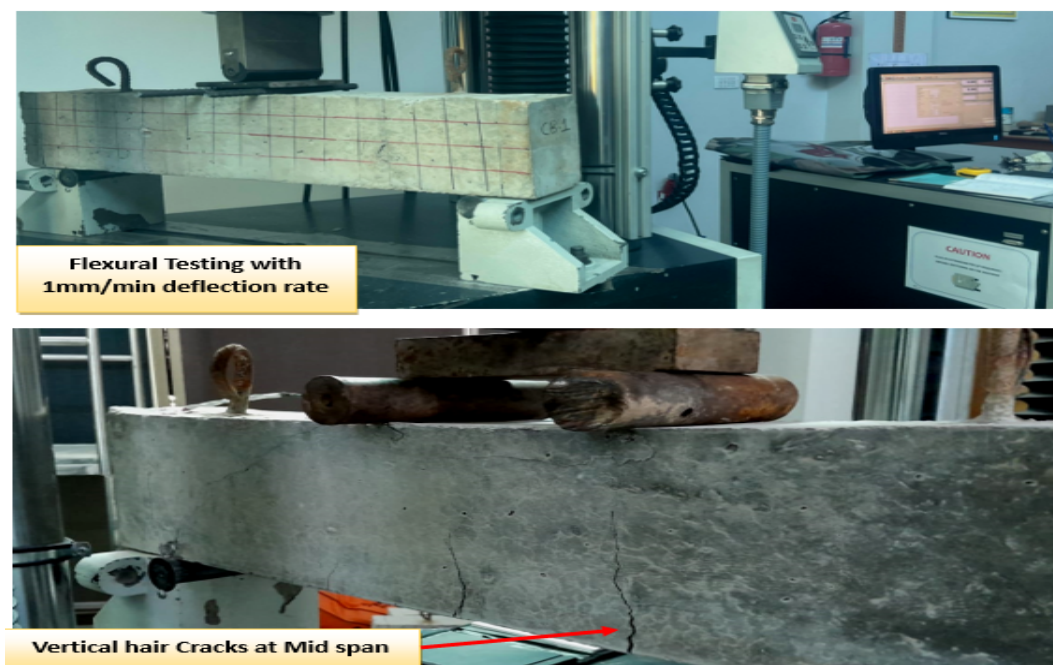
FIGURE 3.35: Flexural Testing with 1mm/min deflection rate

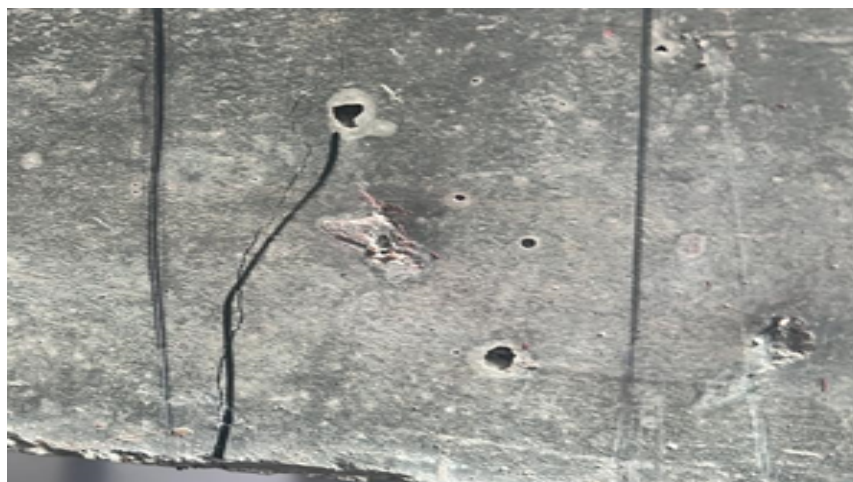
FIGURE 3.37: Vertical hair cracks

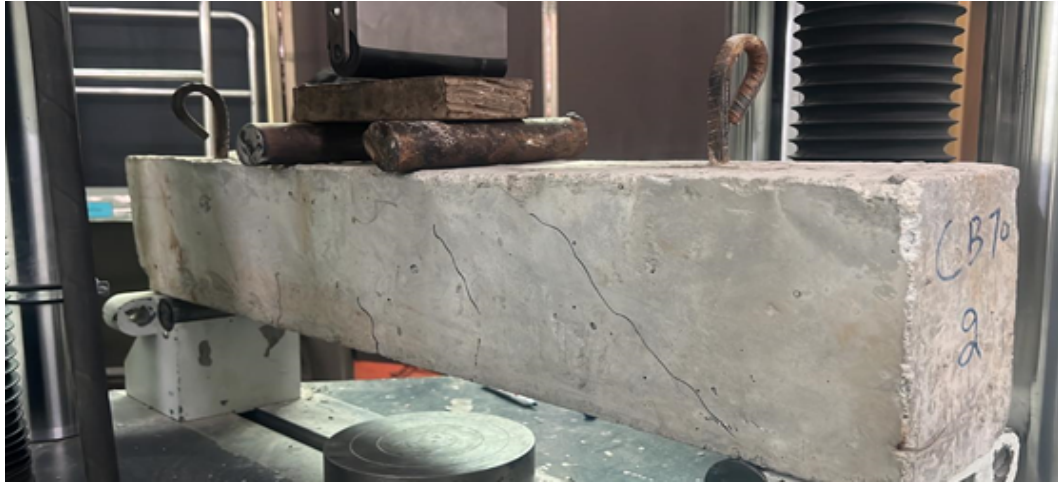
FIGURE 3.38: Diagonal cracks originating from tension zone

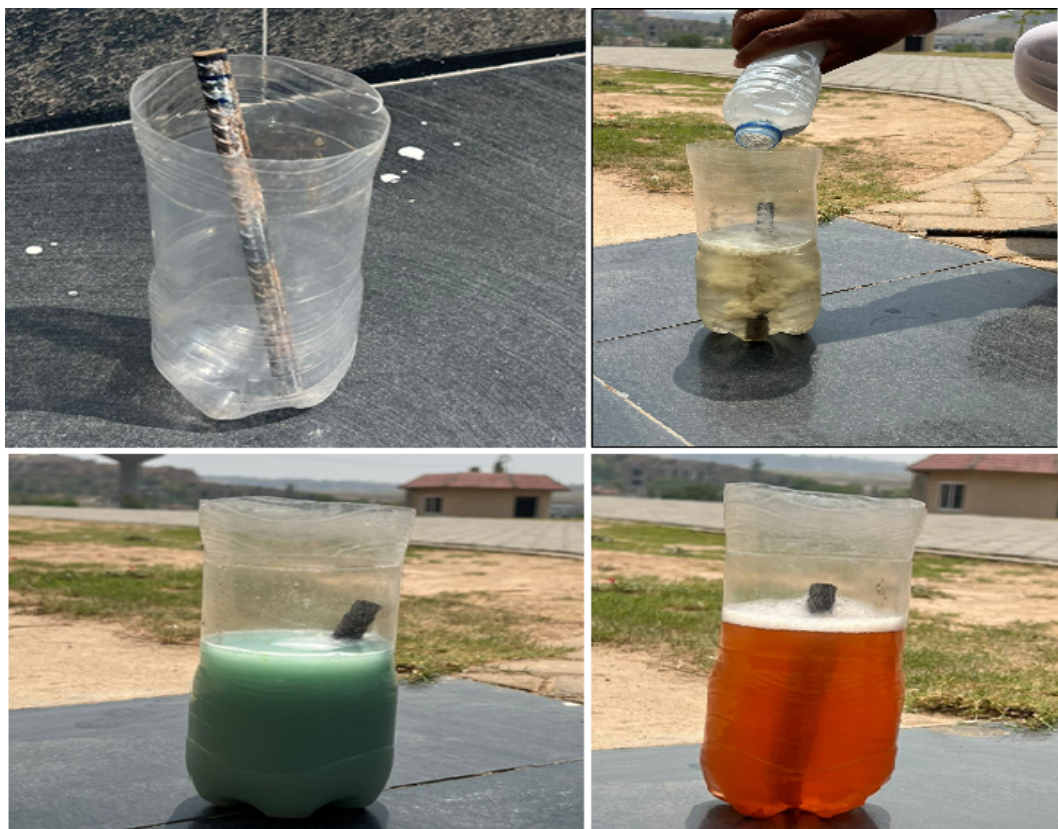
FIGURE 3.49: Procedure to remove rust from corroded steel pieces

make comparison between nominal weight and weight loss. After that, the bars are rinsed in bleaching agents based on chlorine, such as 200 g/l sodium hydroxide, ammonium hydroxide, and sodium alkyl (C10-13) benzene sulfonate, as advised by ASTM G-I-90 (1999) [37] standard to get rid of the rust products. After drying,

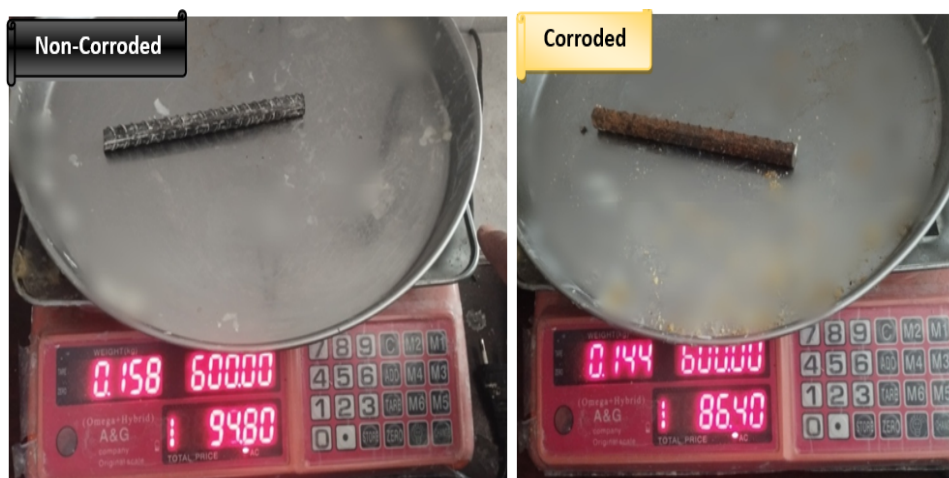
FIGURE 3.50: Comparison of weights from flexural bars away from cathode and far corner

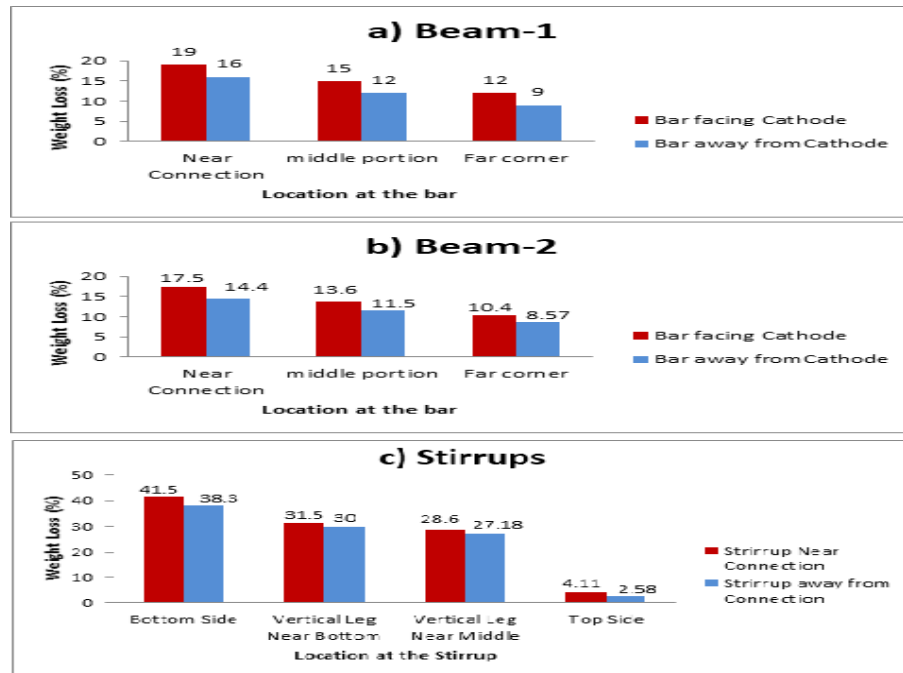
FIGURE 4.7: Explains % weight loss at diff locations of a) beam-1, b) beam-2, c) stirrups

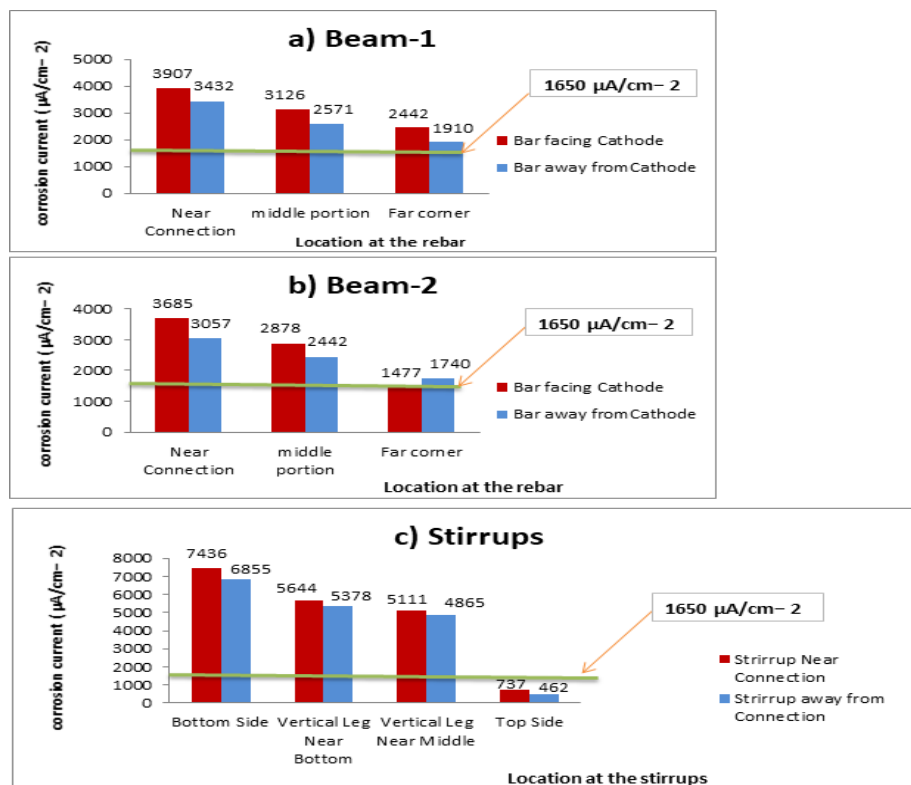
FIGURE 4.8: Explains actual corrosion current at diff locations of a) beam-1, b) beam-2, c) stirrups

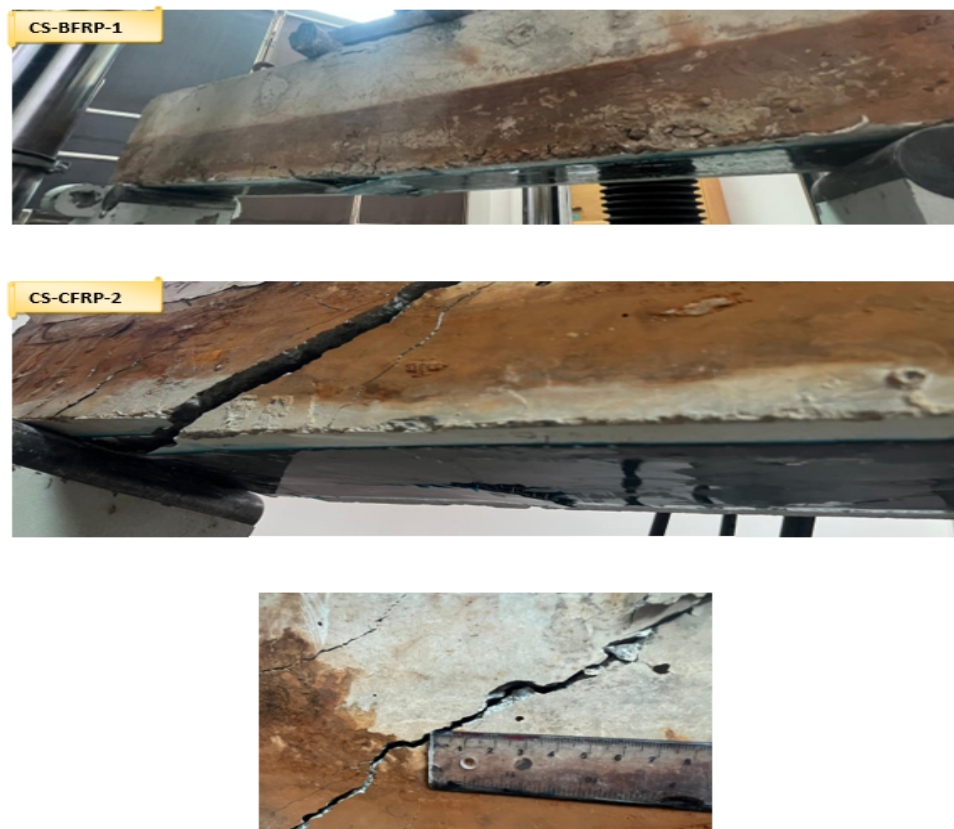
FIGURE 4.10: Laminate tear out at mid span, at supports, and 0.5cm cracks

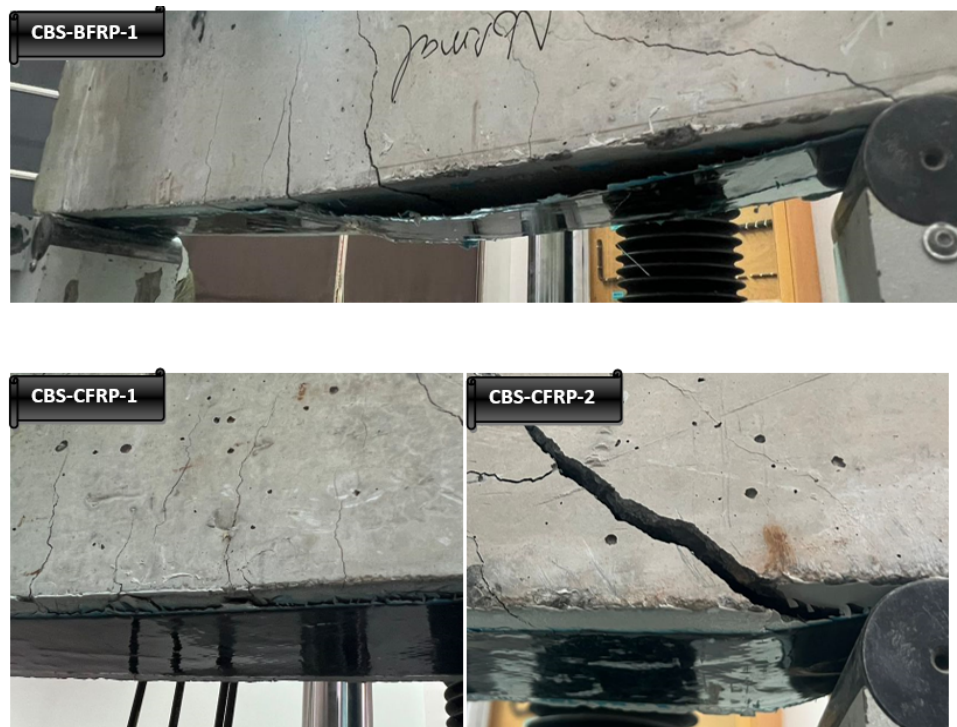
FIGURE 4.11: Adhesive failure and de-lamination

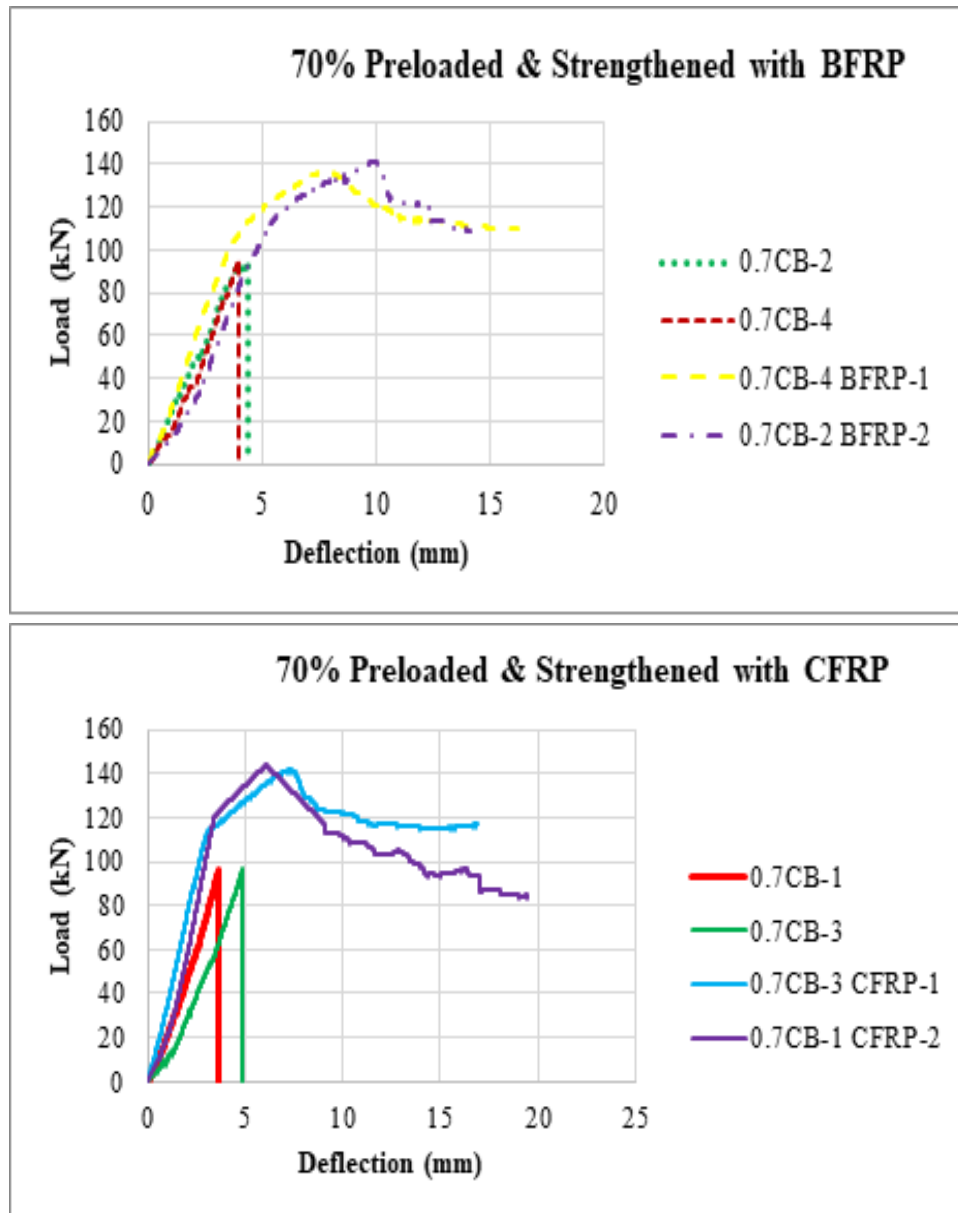
FIGURE 4.15: (c): Load-Deflection curve of pre-loaded beams strengthened with BFRP, (d): Load-Deflection curve of pre-loaded beams strengthened with CFRP
